DUWAMISH MARINA & INDUSTRIAL PARK

RE: Duwamish Marina and Industrial Park

SITE AND PROJECT DESCRIPTION

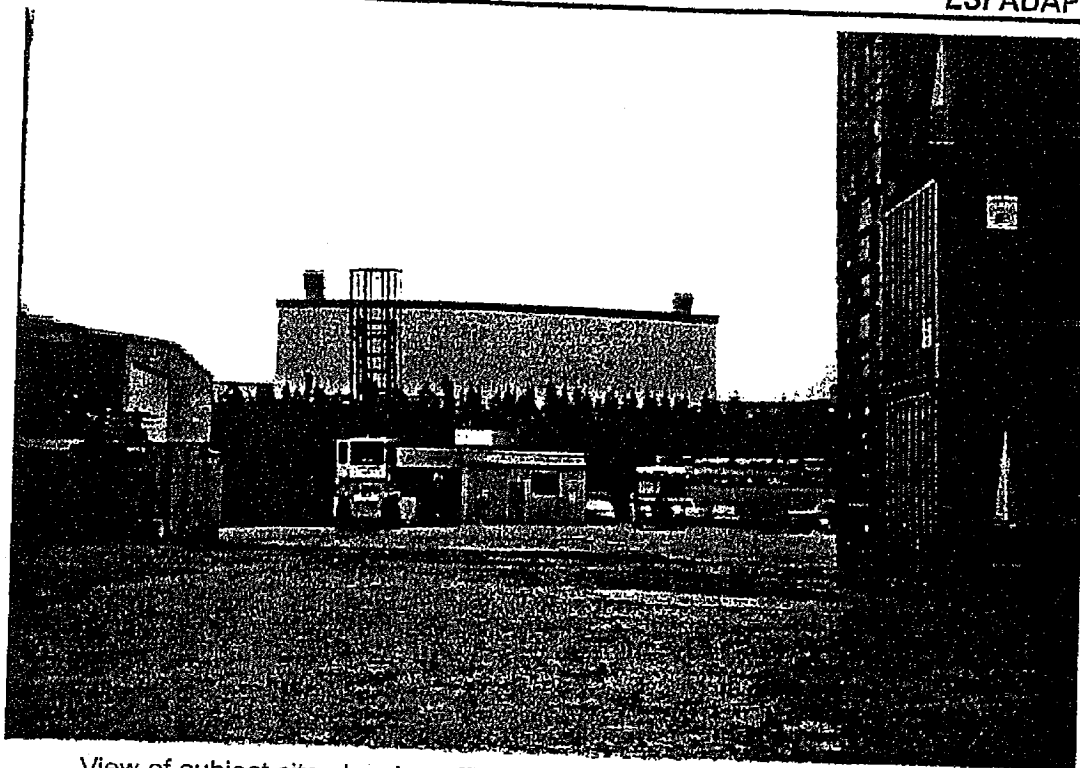
1. View of subject site showing office with main maintenance shop on the left. Note stacked stored freight containers on the right.

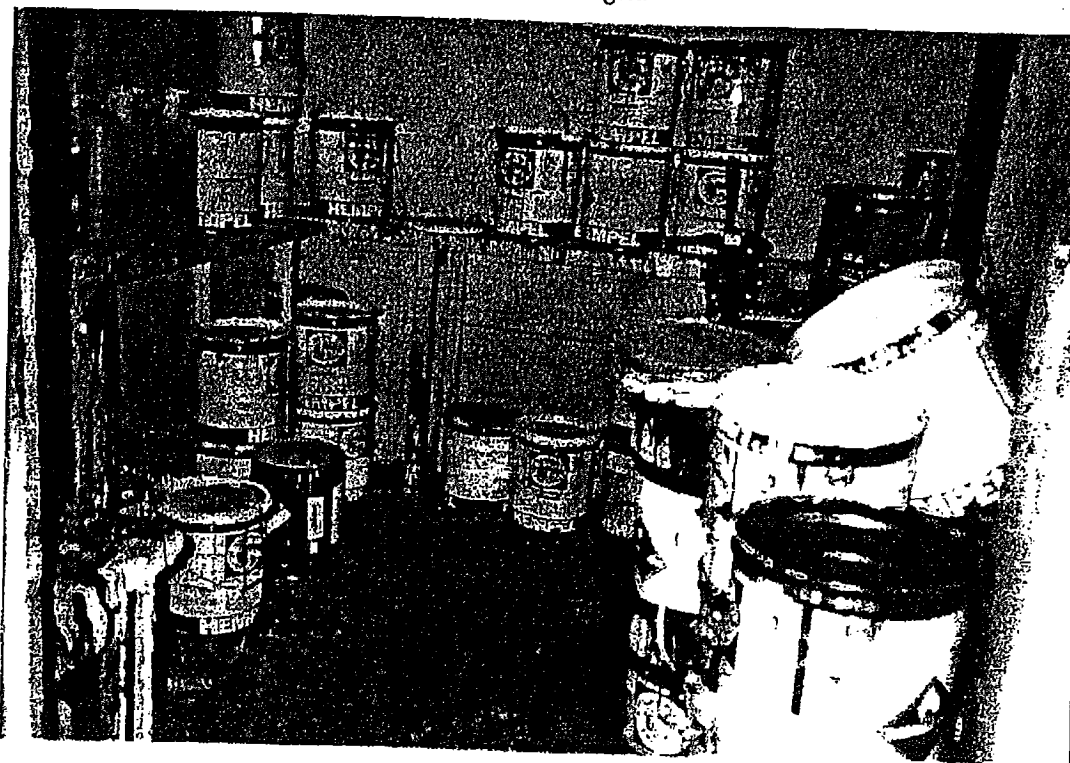
During ADAPT's site visit the paint storage room had an overpowering odor of solvent, likely xylene. During ADAPT's brief visit we noted that there did not appear to be any ventilation for the paint room. ADAPT believes it would be prudent to evaluate the need for ventilation in the paint room to prevent potential human health or fire concerns.

2. View of paint storage room. Note paint staining. Xylene drum on right wall behind paint (black object is pump in drum).

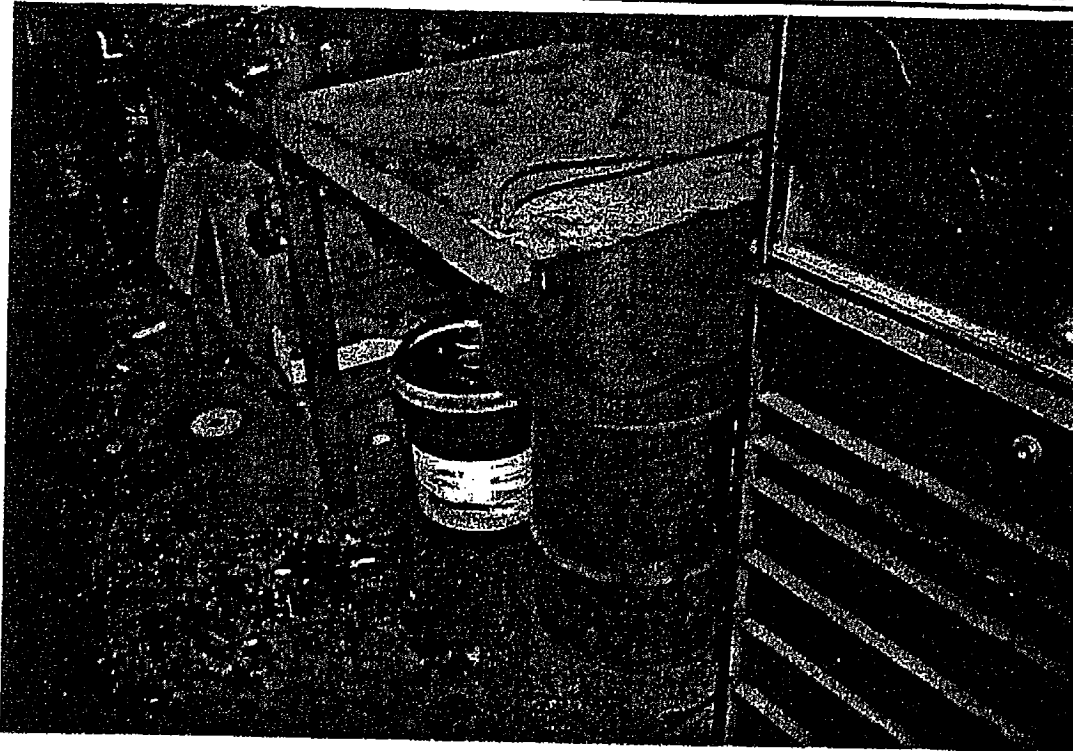
3. View of parts washer on north wall of main shop. Note minor black staining on concrete floor.

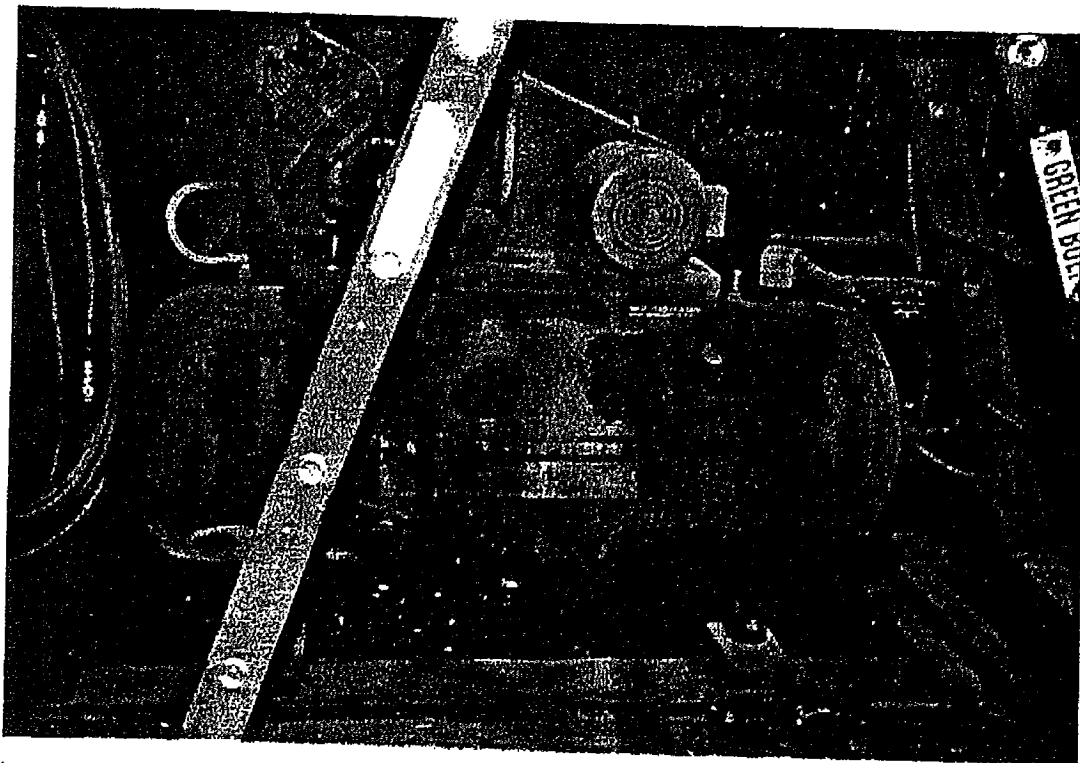
4. View of unused air compressor showing water/oil staining on tank and wall.

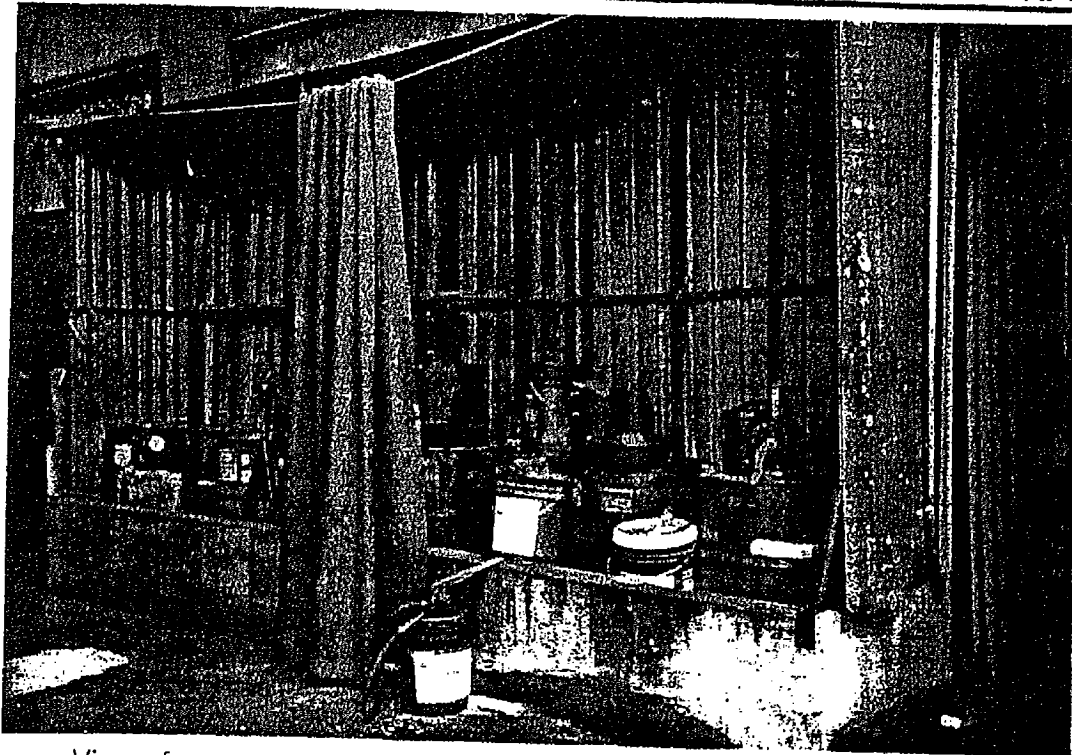
5. View of new and used oil storage area in main shop building. Note absorbent material at lower left.

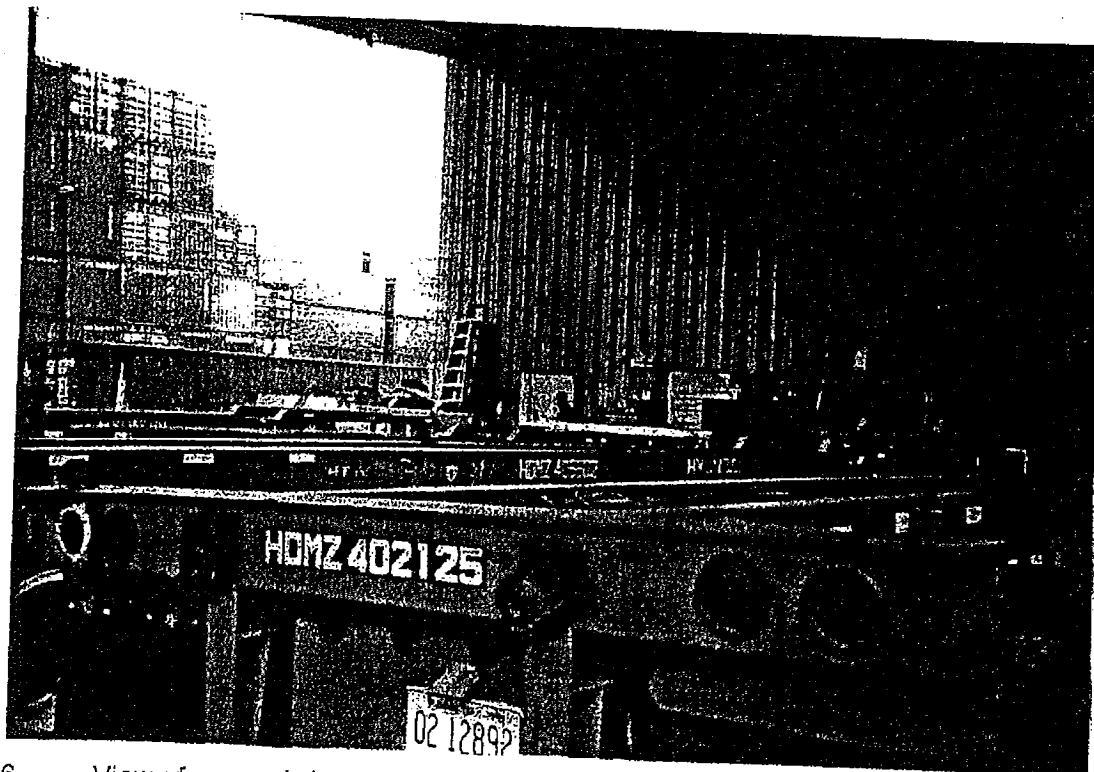
6. View of covered shop area showing trailers being repaired.

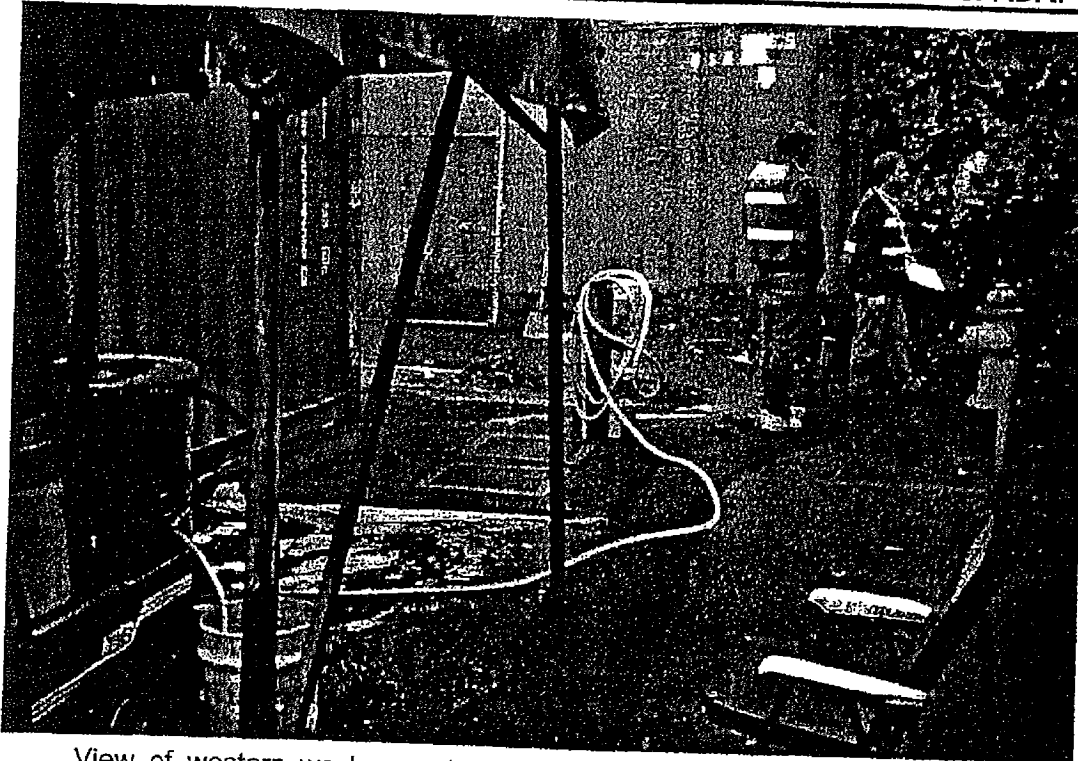
7. View of western wash area trench drain and settling tanks. Trench drain in background and settling tanks are beneath the two metal plates in the center of the photograph. Note asphalt berm surrounding area. Water treatment container in background.

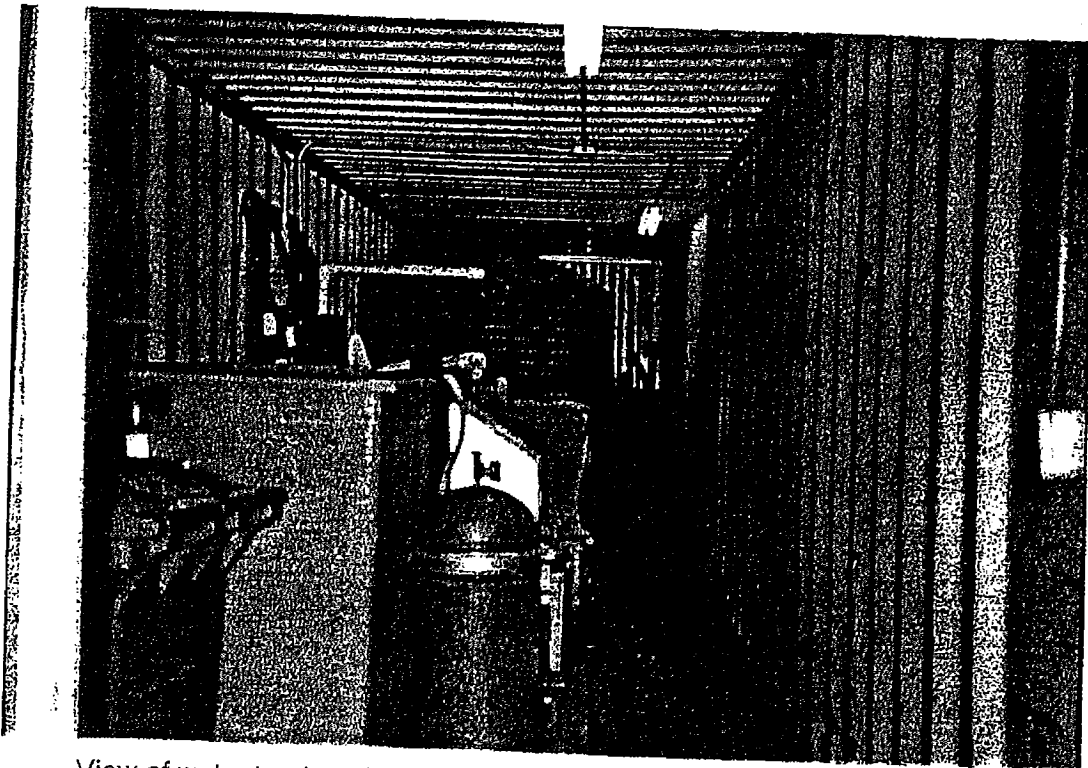
8. View of water treatment equipment in freight container.

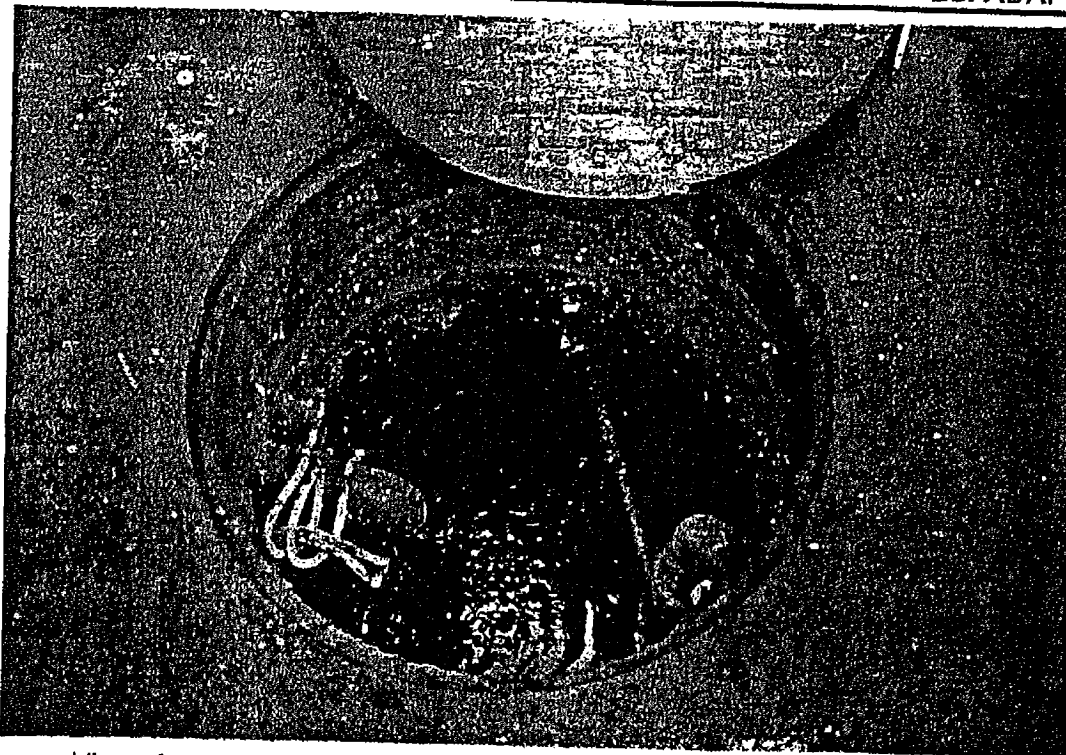
9. View of water collection tank for the eastern wash area.

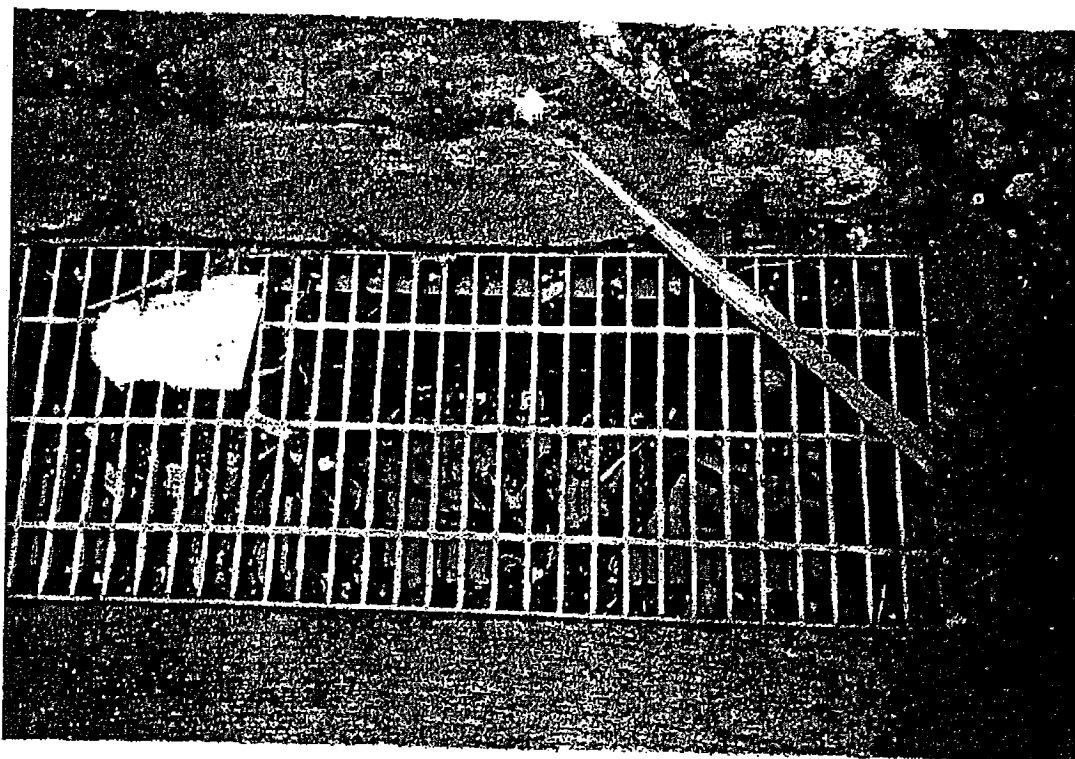
10. Close-up view of trench drain for the eastern wash area. Note debris in water.

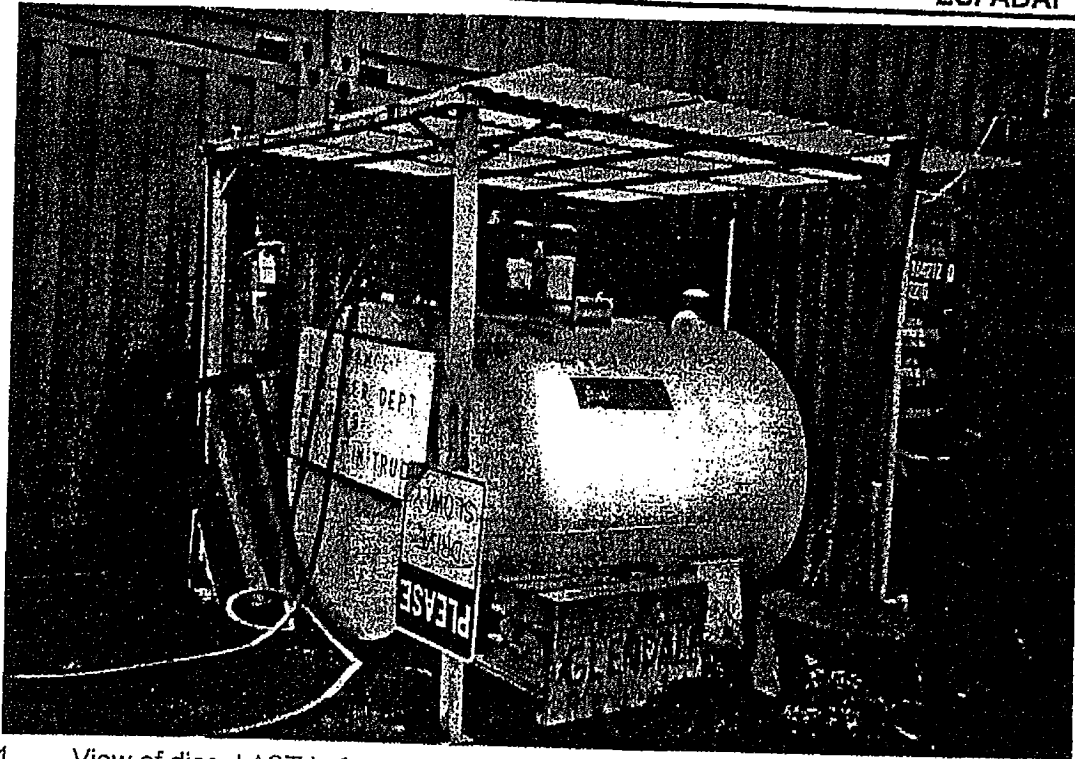
The fueling area is used to fuel the site forklifts. At the time of the site visit the fueling area contained one approximate 500-gallon diesel aboveground storage tank (AST) (Photo 11). The AST is reportedly double-walled and has an approximate four-inch asphalt berm around the tank on the ground. Minor petroleum stains were noted on the ground around the tank.

11. View of diesel AST in fueling area. Note minor staining on asphalt near hose.

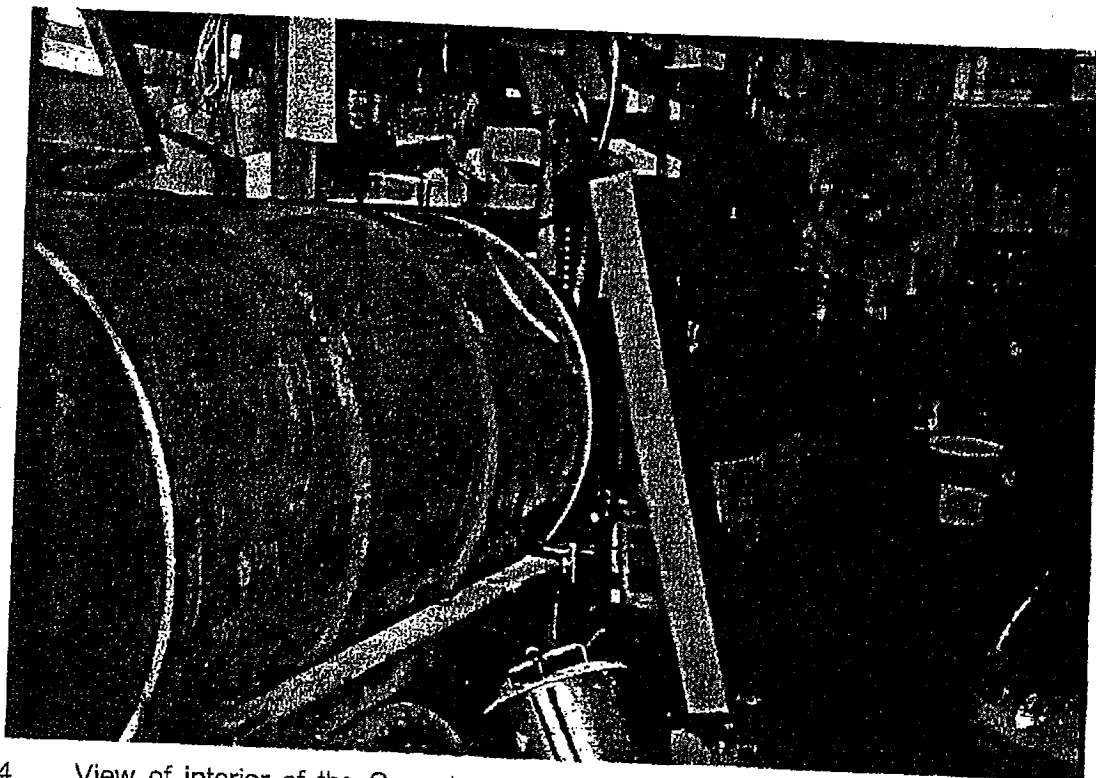
14. View of interior of the Genset repair shop (container). Note plastic secondary containment for the miscellaneous drums and containers of oil, and diesel.

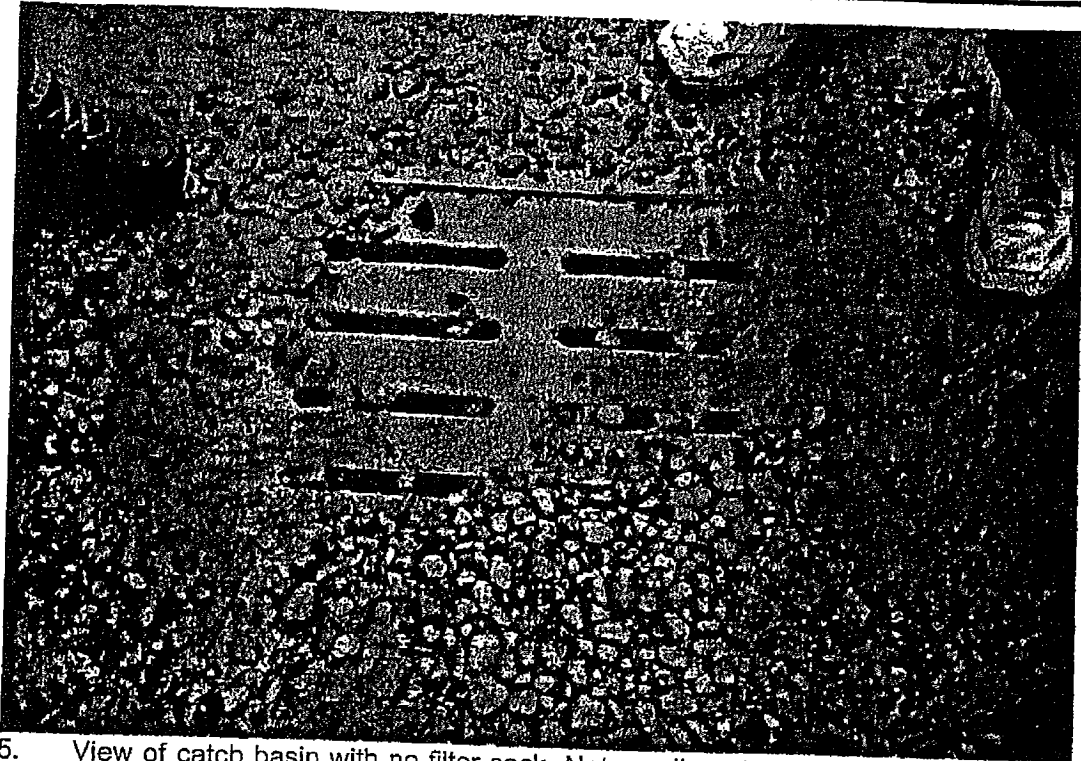
15. View of catch basin with no filter sock. Note sediment and rocks entering basin. This catch basin located in the unpaved area of the site in the container storage area near the entrance gate.

At the time of ADAPT's site visit several of the storm drain catch basin filter socks were either missing or had holes or tears. The purpose of the filter socks is to prevent the discharge of sediment laden water into the storm water sewer. BMPs and Storm Water Prevention Plans suggest filter socks to help reduce the sediment discharge from storm water runoff. On-site personnel indicated during the site visit that all filter socks are reportedly replaced twice a year and that the filter socks are routinely monitored between semi-annual replacements. Based on the observations, ADAPT believes it would be prudent to increase the frequency of monitoring to identify damaged socks with immediate replacement to reduce the discharge of sediment into the storm sewer system.

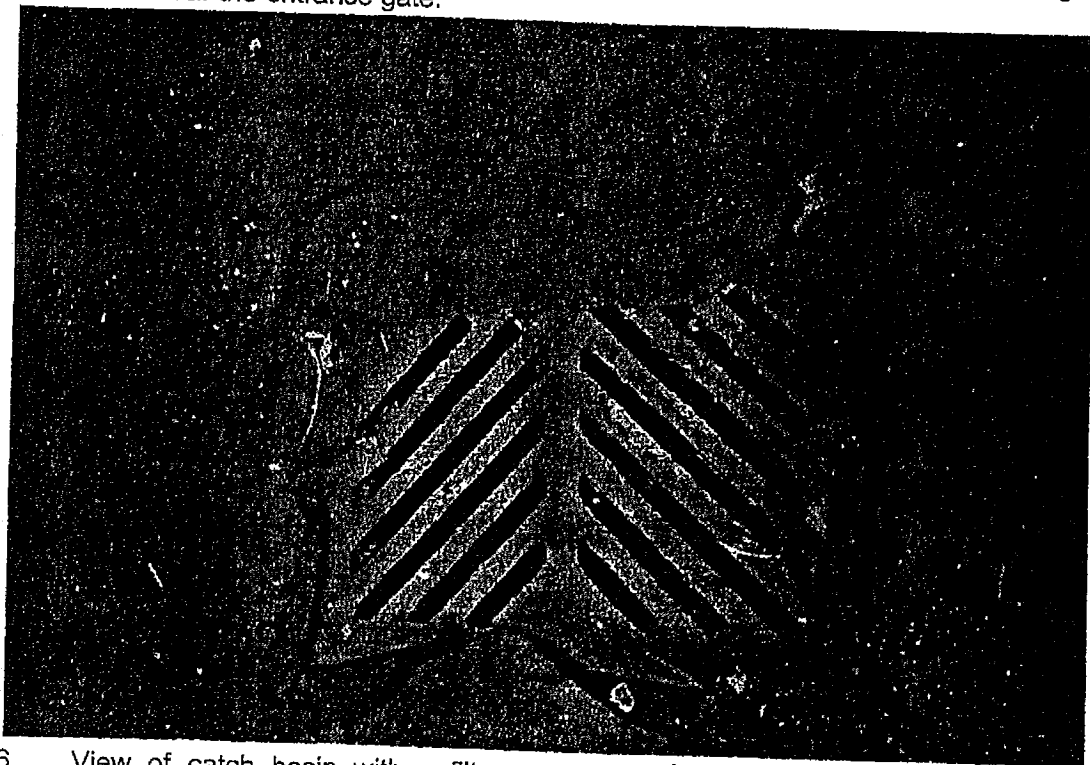
16. View of catch basin with a filter sock. Filter sock appeared almost full of sediment. This catch basin was located in the asphalt paved area of the container storage area.
